High Line Canal Stormwater Conversion

Design Report

Executive Summary

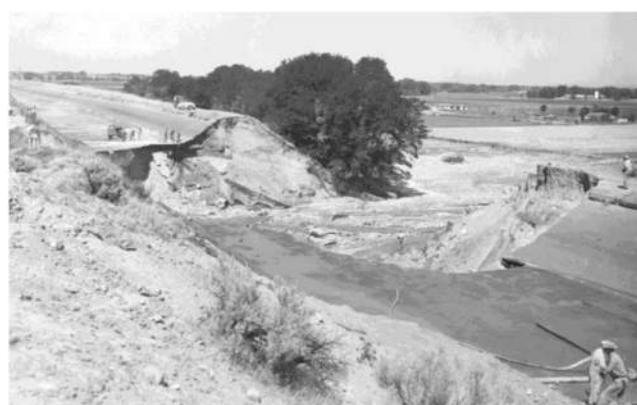
Figure 2 - USBR, example ditch embankment failure

Both features share the risk of water retained behind an earthen embankment. The earthen embankment is a gravity mass able to withstand the weight of the water and protect downstream properties from the canal water. When there is more water than the canal can convey, the embankment is overtopped. Water spills down the face of the embankment following natural watercourses. However, floodwater spills over the earthen embankment cause rilling and scour. This can lead to embankment instability, erosion, and ultimate breach of

the embankment spilling all tributary canal water at the breach. This is a significant risk to downstream people and property as a rapid 'flash flood' is unleashed on downstream areas. (Reference: Bureau of Reclamation, Canal Operation and Maintenance, Embankments; https://www.usbr.gov/assetmanagement/docs/Canal_Embankments.pdf)

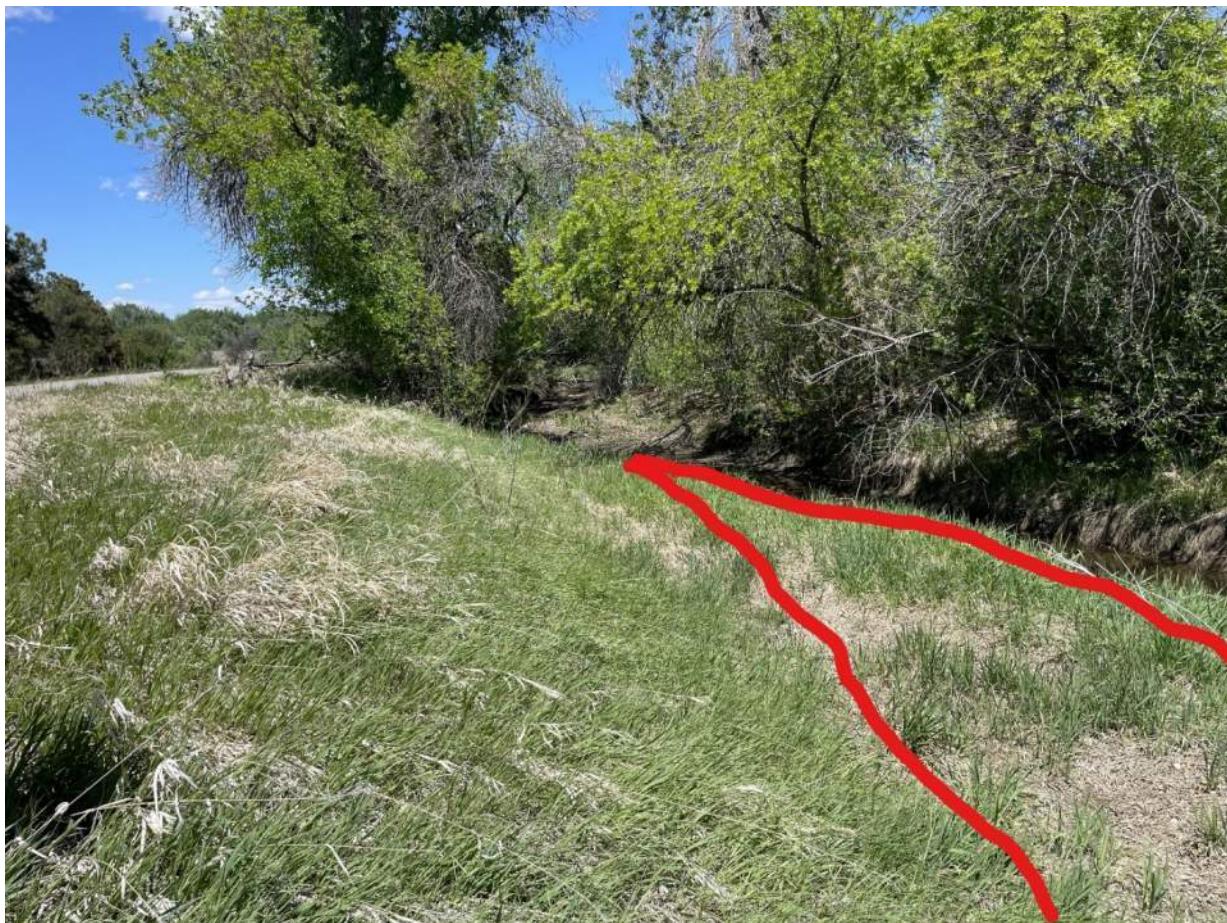
Figure 9 Potential Wetland Bench Opportunity

There is an opportunity to modify existing grades in select areas that have the potential to create wetland plant communities to capitalize on the modified outflows proposed with this project. In these locations, existing low benches can be intentionally redesigned and or paired with existing mud flat areas to take advantage of anticipated flows with targeted weir design considerations and slight grading adjustments. An example of this can be seen in Figure 8, below, where a proposed wetland bench along the canal is shown. These minor adjustments to the proposed improvements can help promote revegetation opportunities and ecological function within the High Line Canal that could have long-term benefits for the Village.

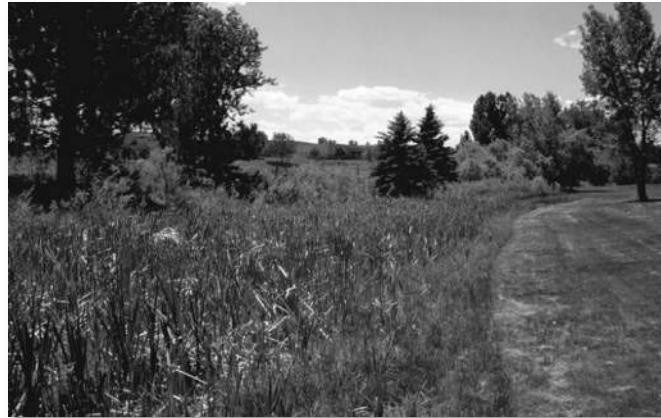
Photograph 2-1. Preserving a natural floodplain, including wetland areas, and using this area for flood control and conveyance, represents sound engineering in concert with established Colorado drainage law.

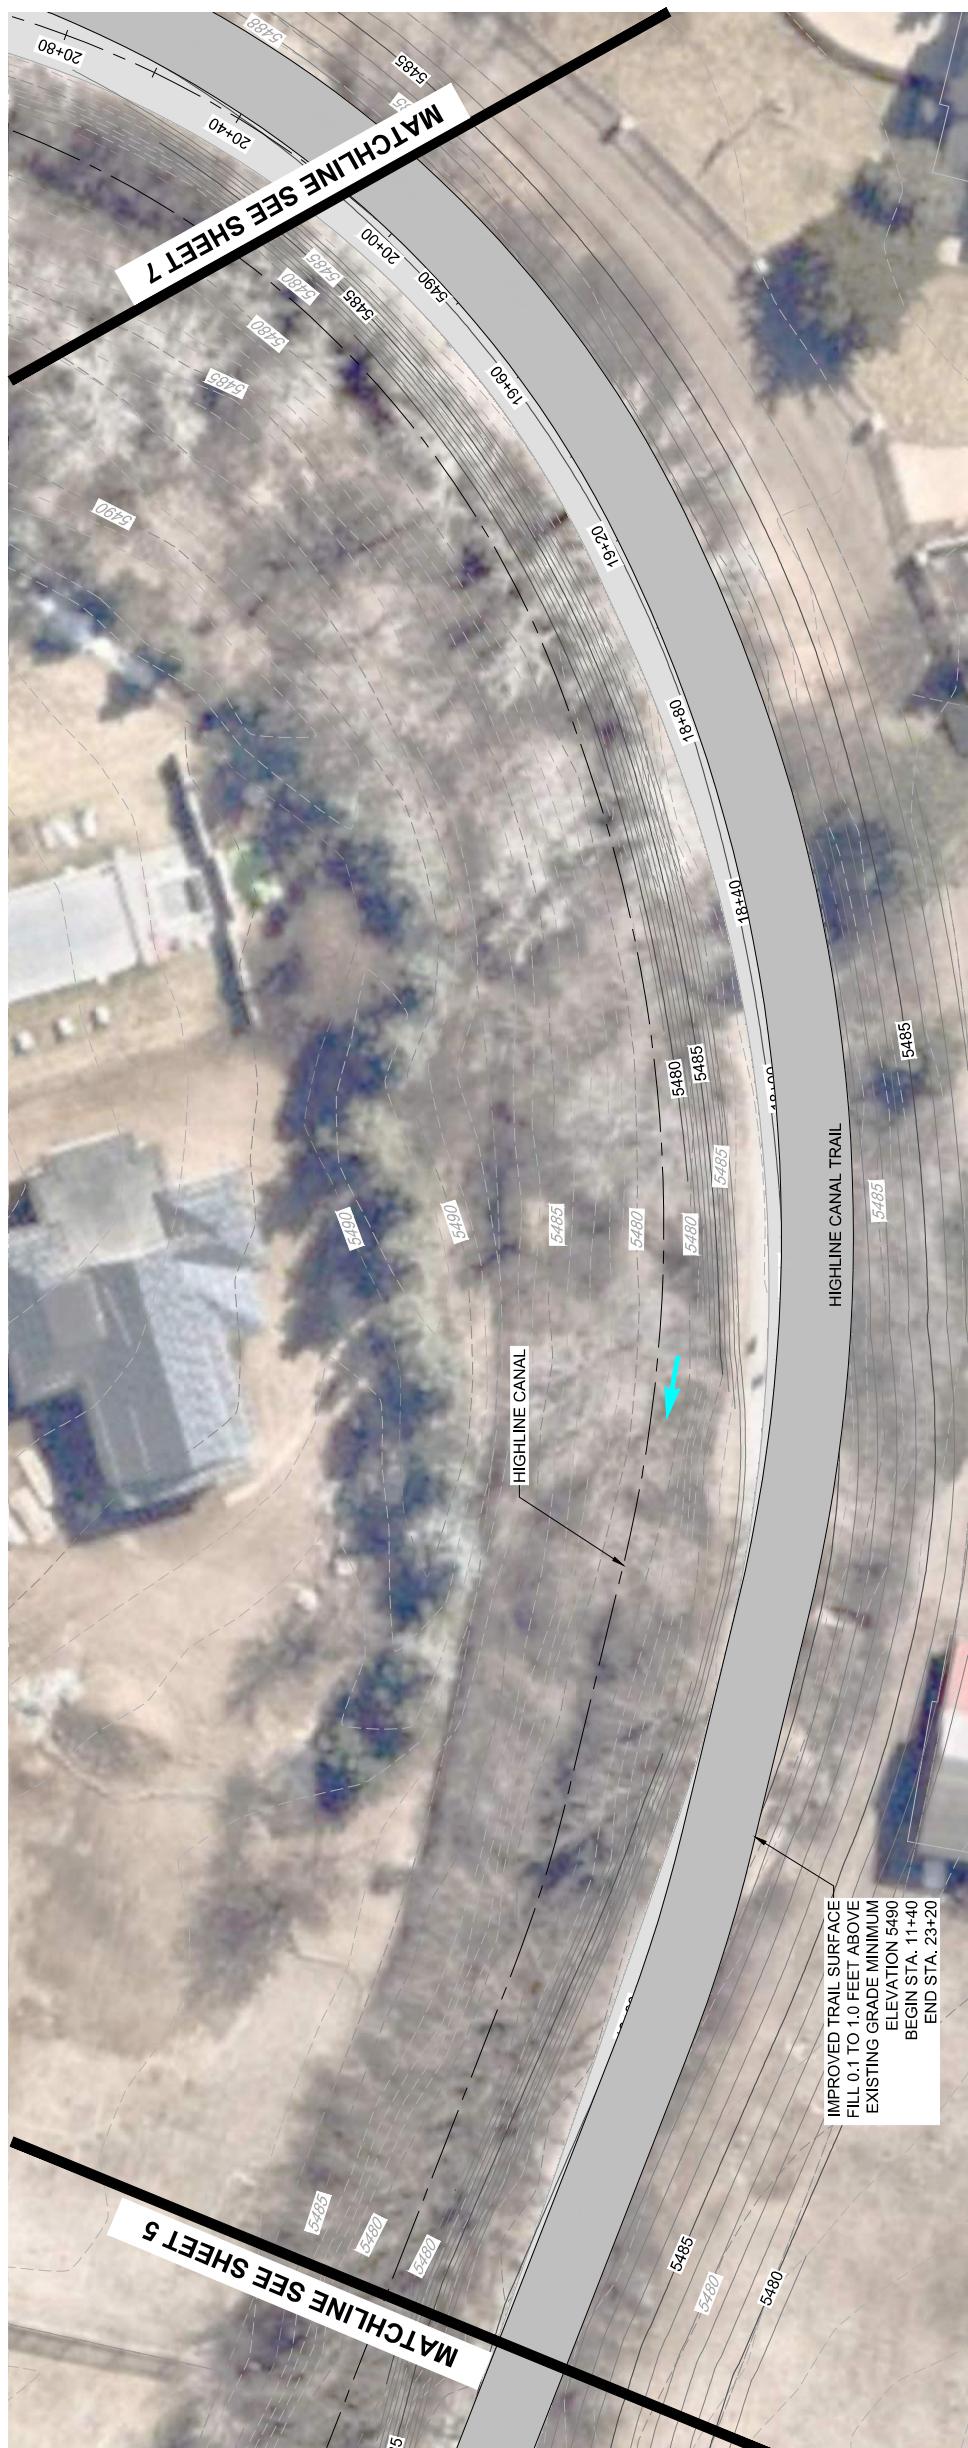
HIGHLINE CANAL TRAIL

PROFILE OF CE-HLC TRAIL
H: 1" = 20
V: 1" = 5

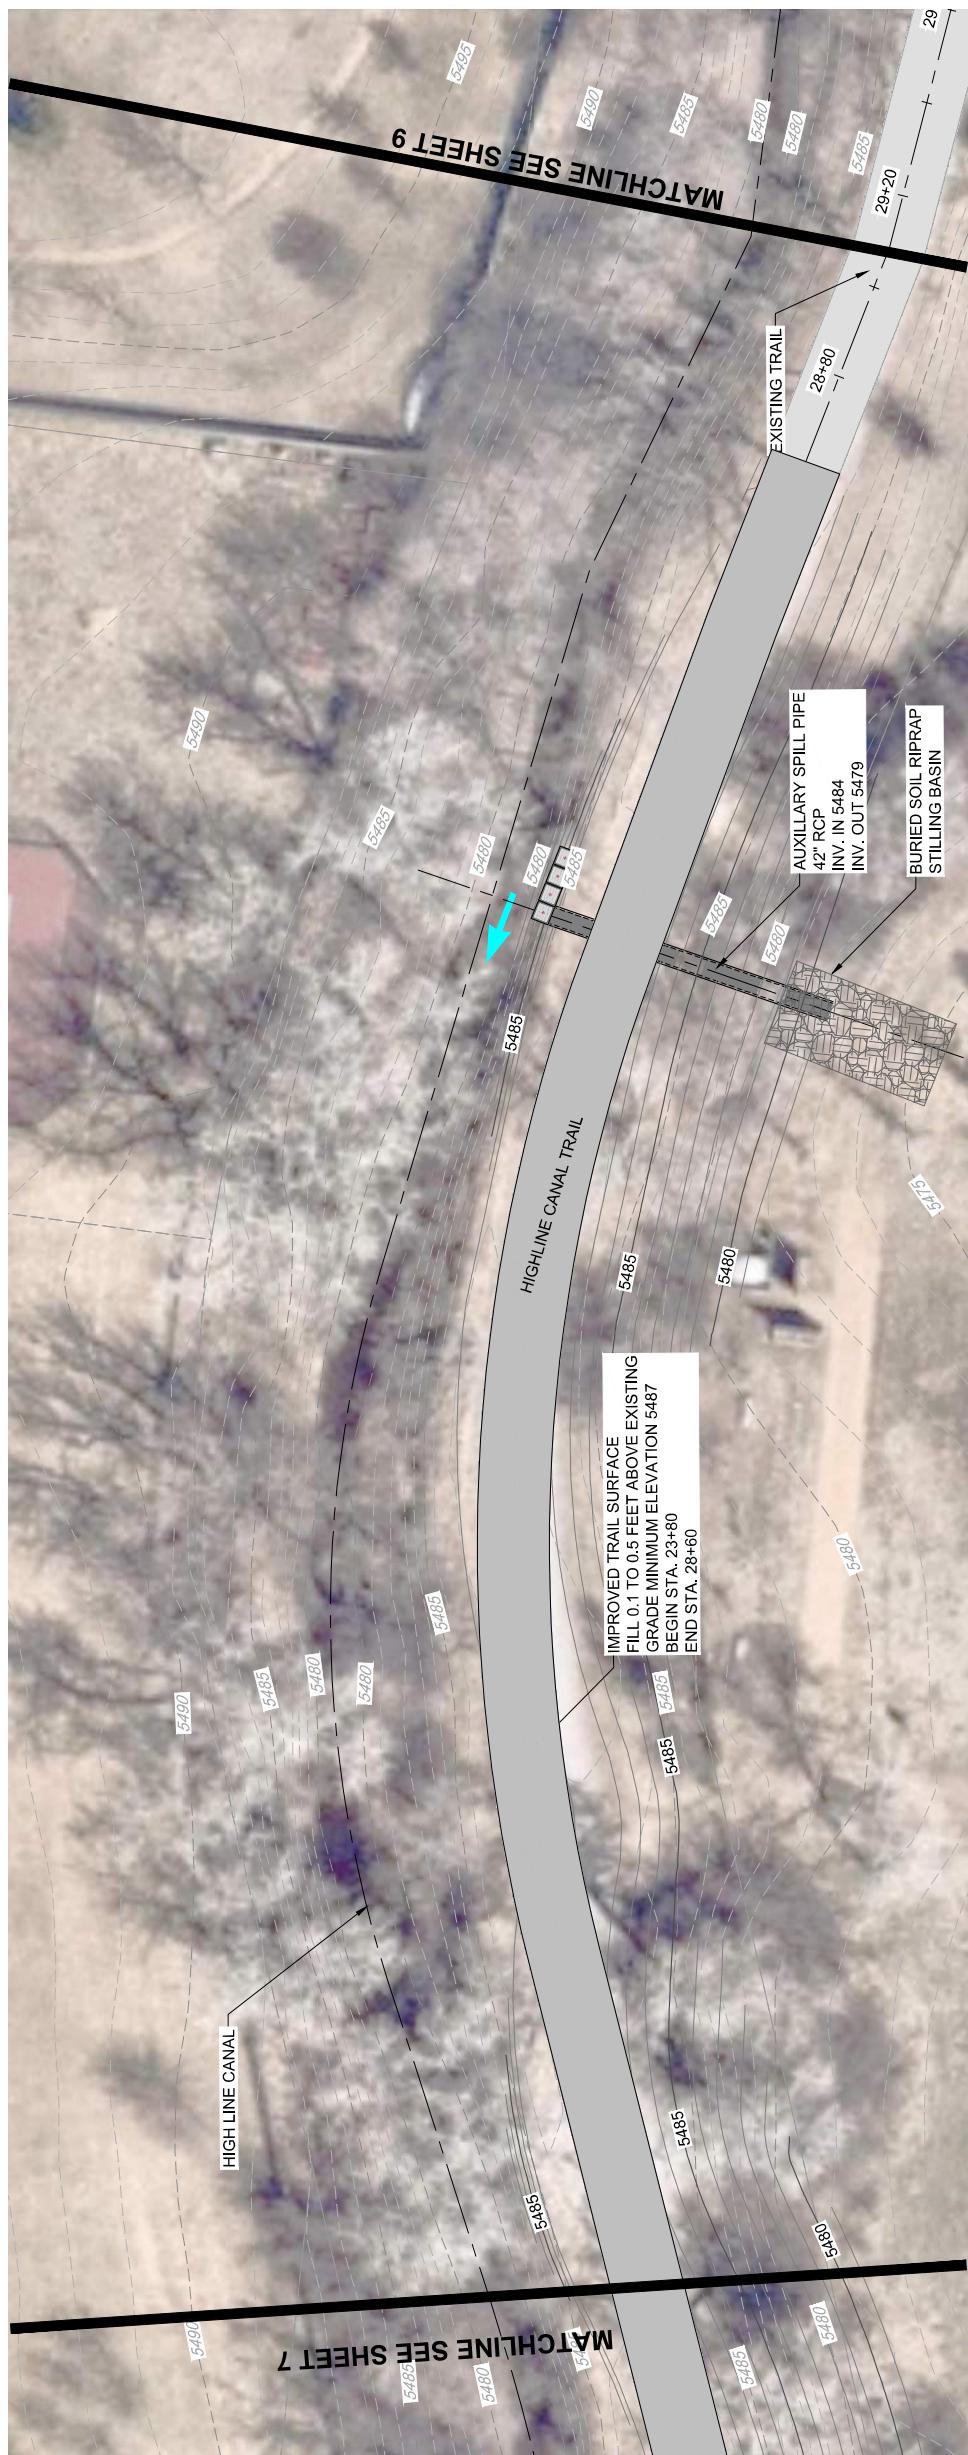
PROFILE OF ALIGNMENT - COLORADO OUTLET

PROFILE OF CE-HLC TRAIL

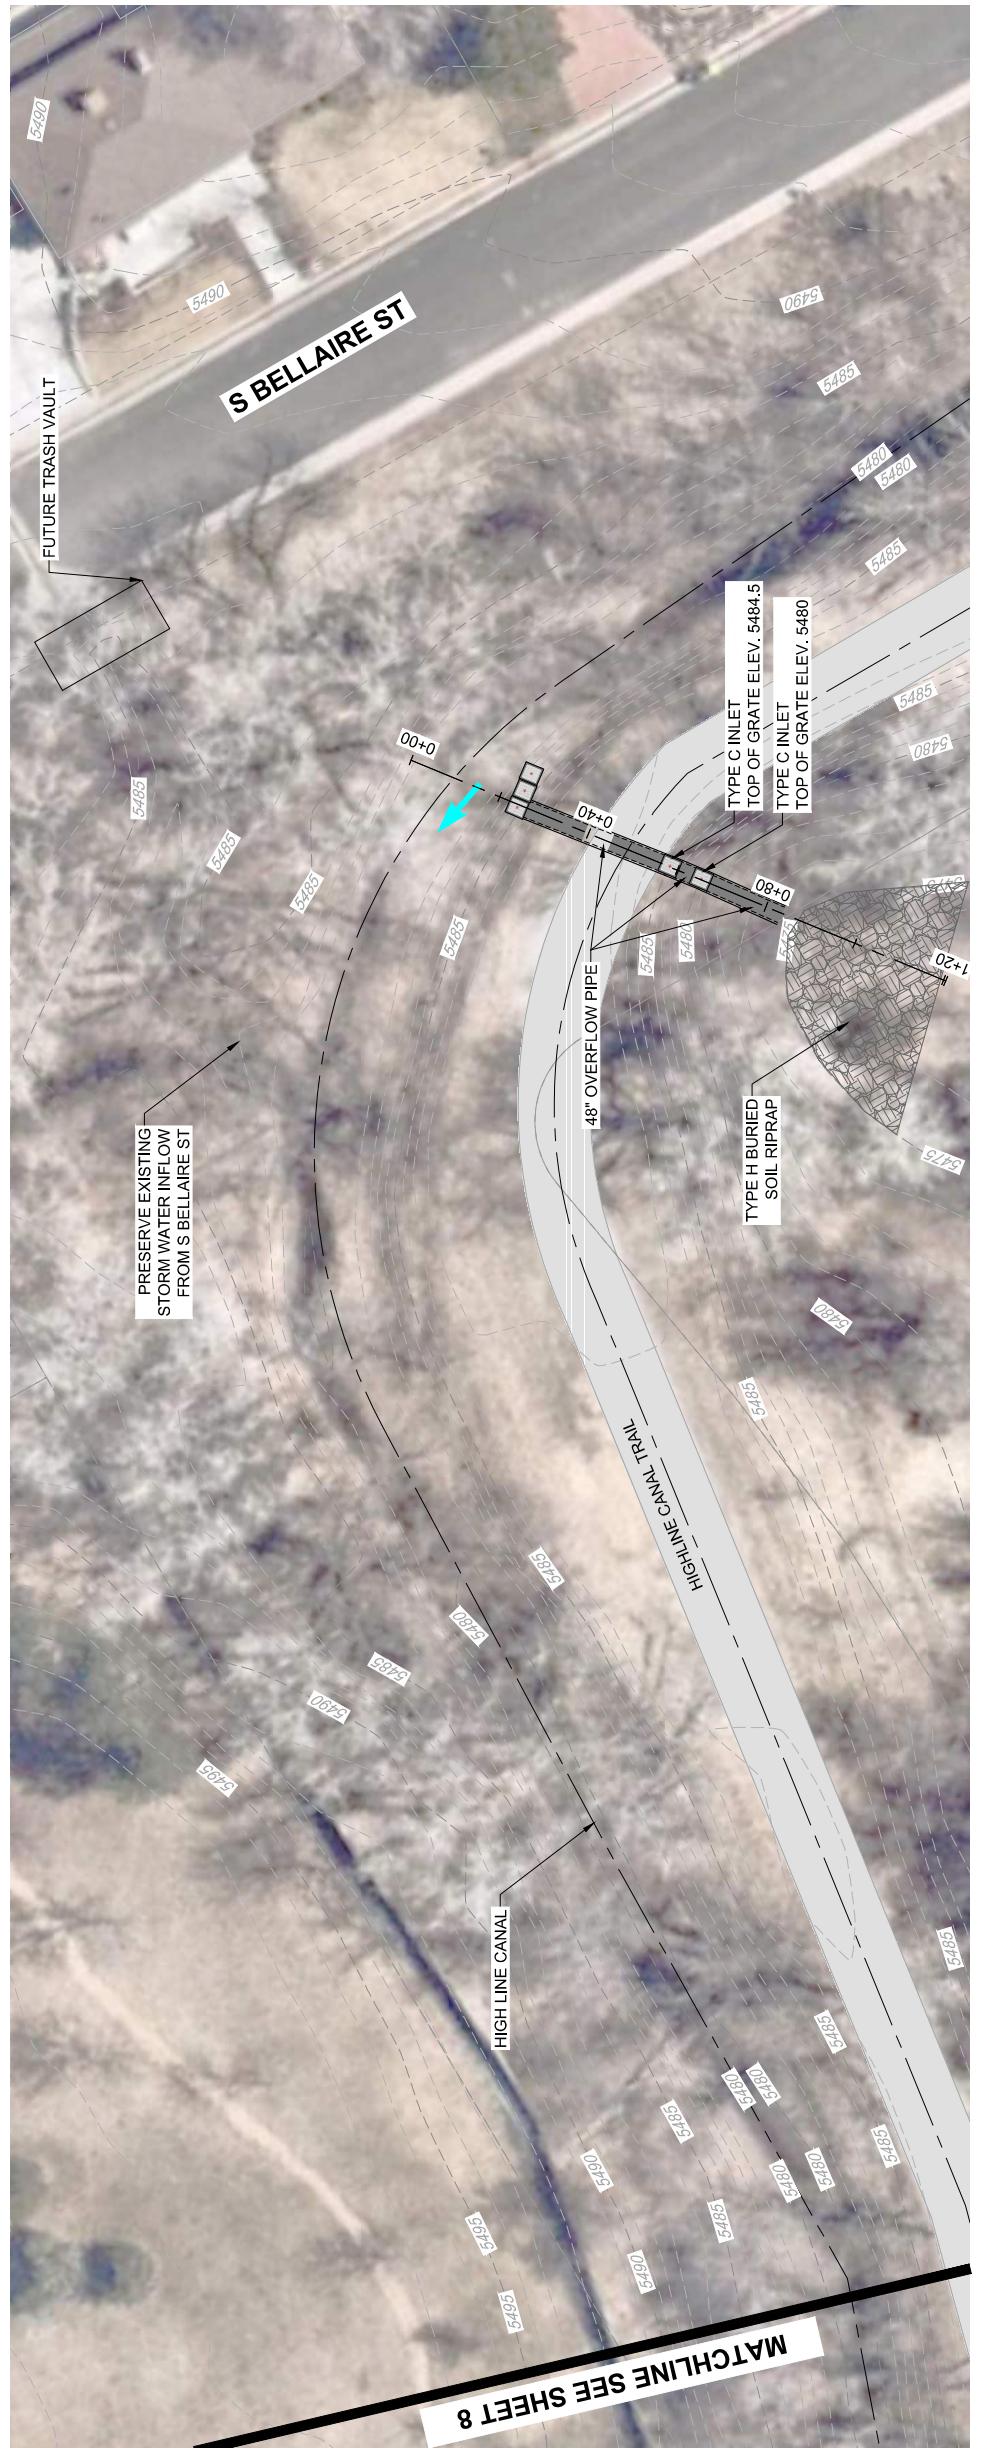
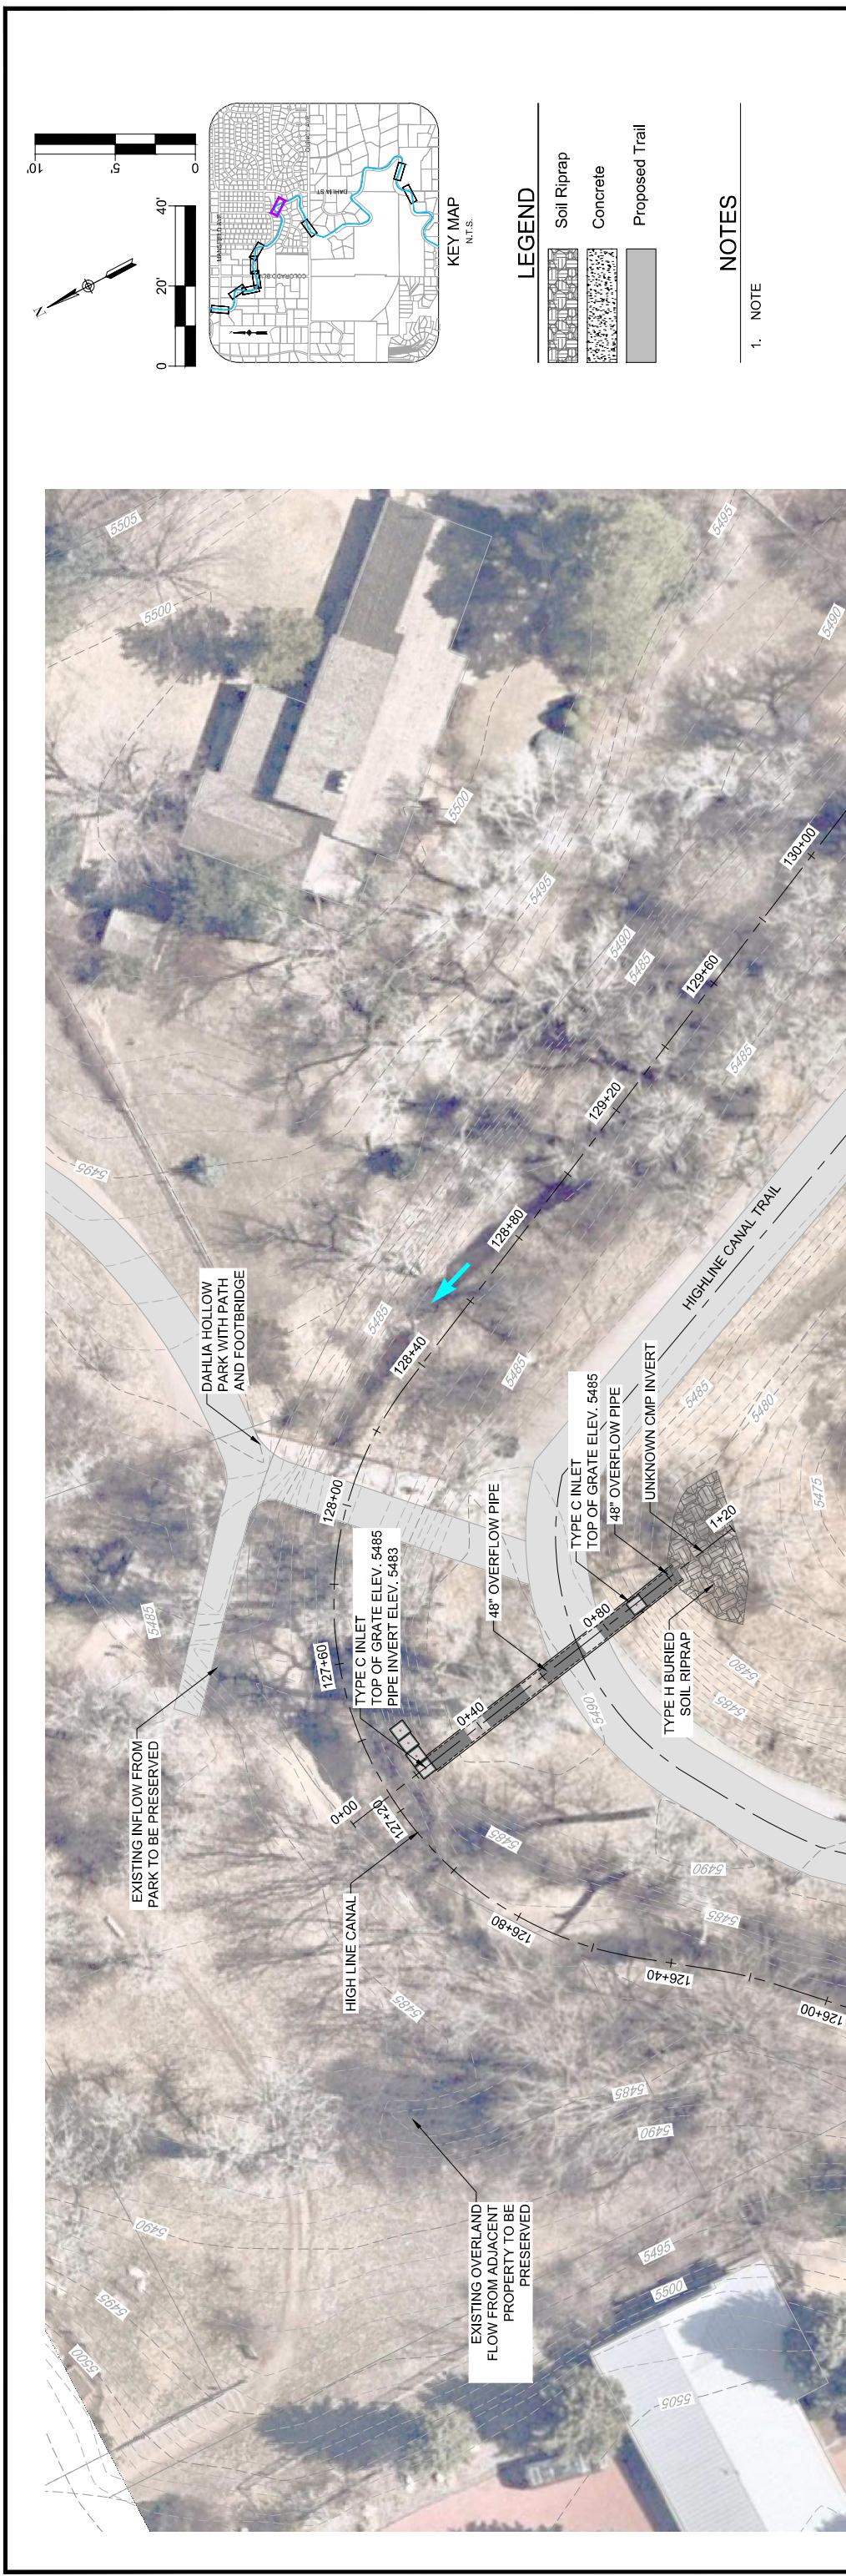
PROFILE OF ALIGNMENT - THREE PONDS OUTLET
H: 1" = 20
V: 1" = 5

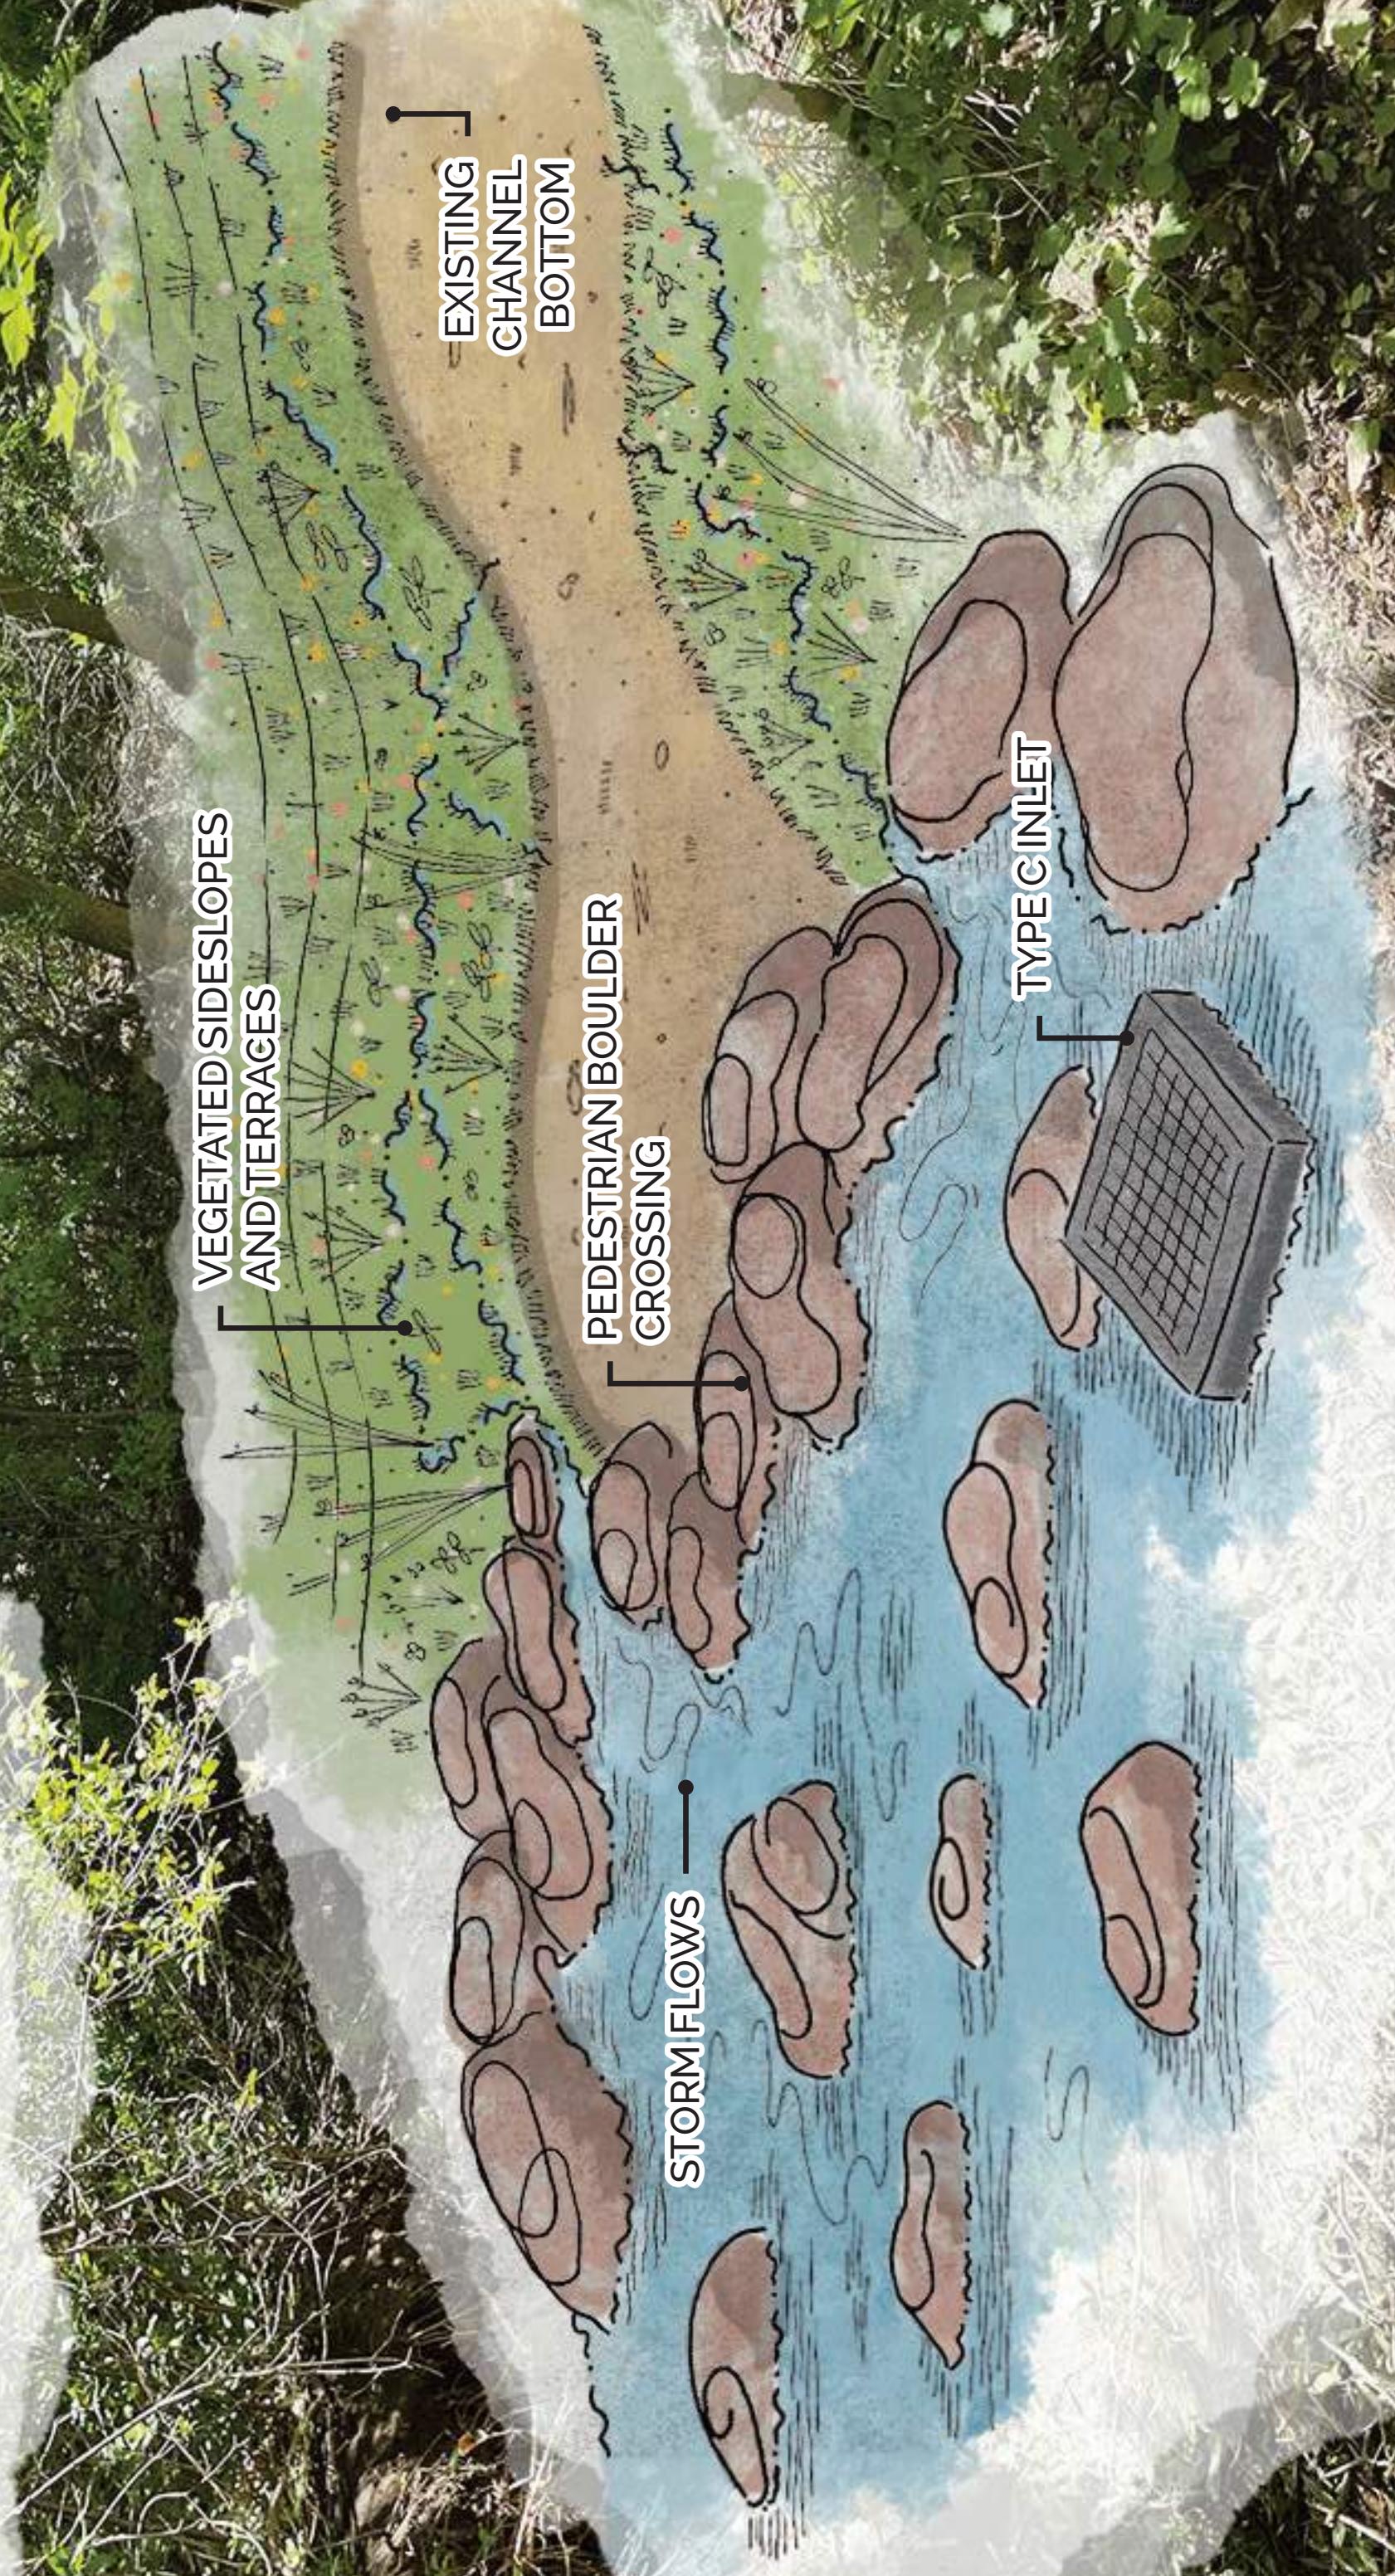
DAHLIA WATER QUALITY BERM PROPOSED CONDITIONS
